**Flood Control Project Maintenance
Levee Inspections**
LMA District Cover Sheet
Spring 2010 Levee Inspection Results

Lower San Joaquin Levee District

Levee Inspection Report By Mile - Spring 2010

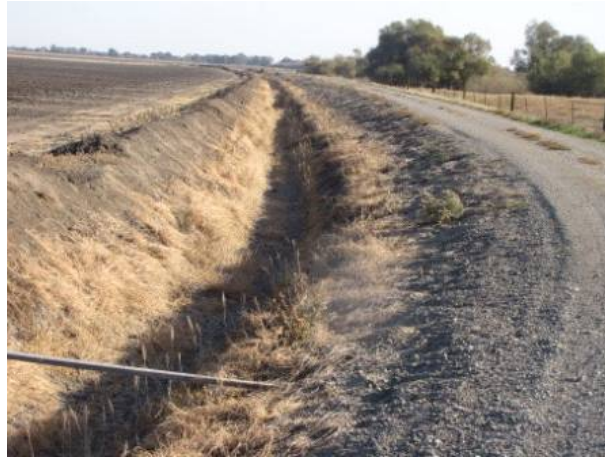
richard_s_20100505_004.jpg

Levee Mile Report Line	5
Start Levee Mile	22.09
End Levee Mile	22.56
Location	Land Side
Category	Earthen Levee
Item	Encroachments

Looking at landside ditch at levee toe.

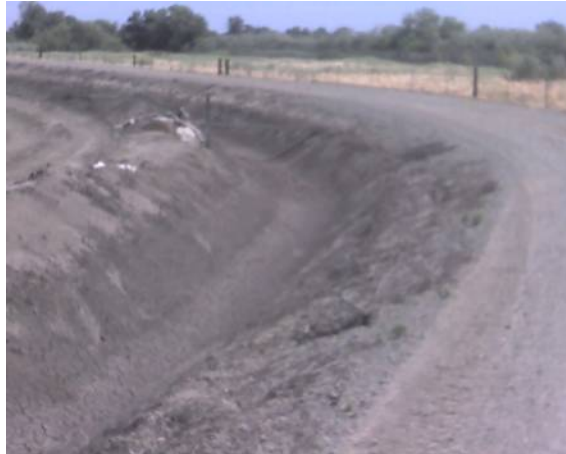
richard_s_20100601_093.jpg

Levee Mile Report Line	5
Start Levee Mile	22.09
End Levee Mile	22.56
Location	Land Side
Category	Earthen Levee
Item	Encroachments

Looking southeast at ditch along landside toe.

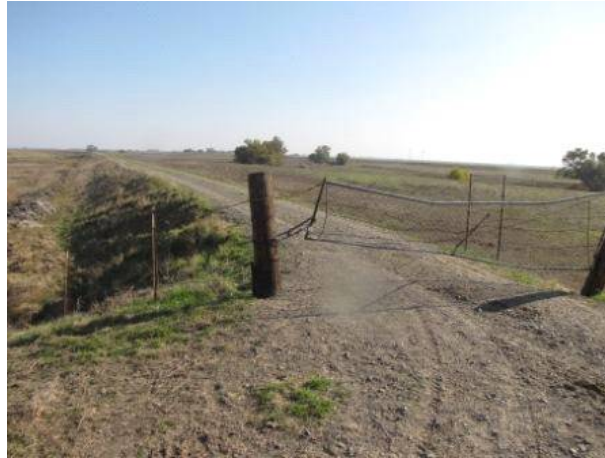
richard_s_20100505_011.jpg

Levee Mile Report Line	5
Start Levee Mile	6.58
End Levee Mile	6.58
Location	Crown
Category	Earthen Levee
Item	Repair Gates

Looking south at damage gate.

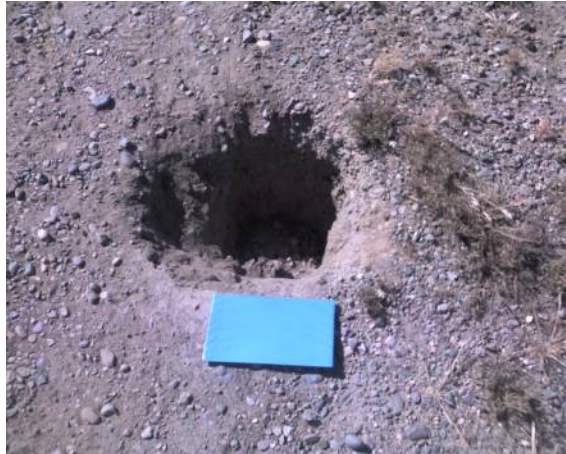
richard_s_20100524_085.jpg

Levee Mile Report Line	9
Start Levee Mile	29.80
End Levee Mile	29.80
Location	Land Side
Category	Earthen Levee
Item	Crown Surface / Depressions / Rutting

Looking at 6 inch hole on crown of levee.

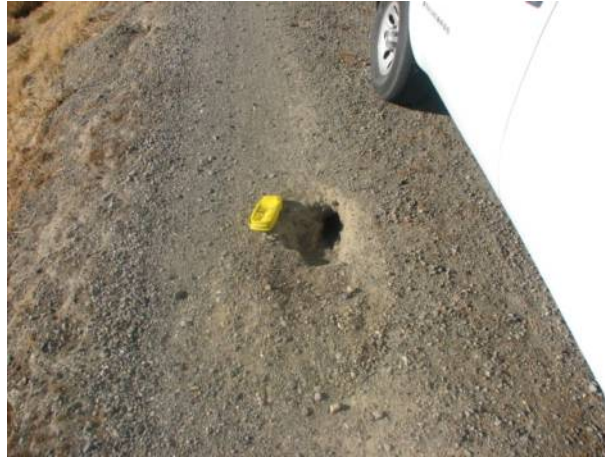
richard_s_20100505_012.jpg

Looking at squirrel hole at crown of levee.

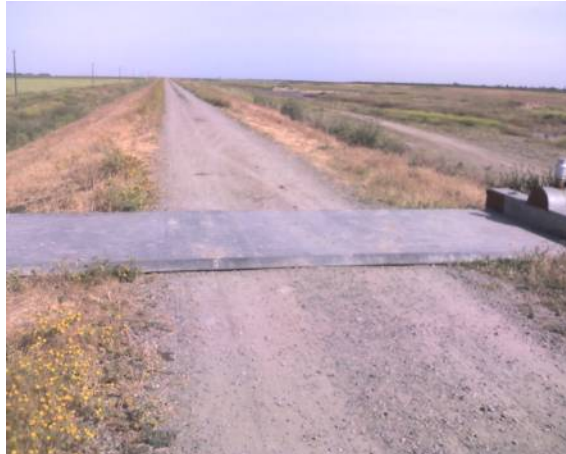
richard_s_20100601_087.jpg

Levee Mile Report Line	9
Start Levee Mile	32.96
End Levee Mile	32.96
Location	Land Side
Category	Earthen Levee
Item	Encroachments

Looking north at ramp with pipes crossing crown.

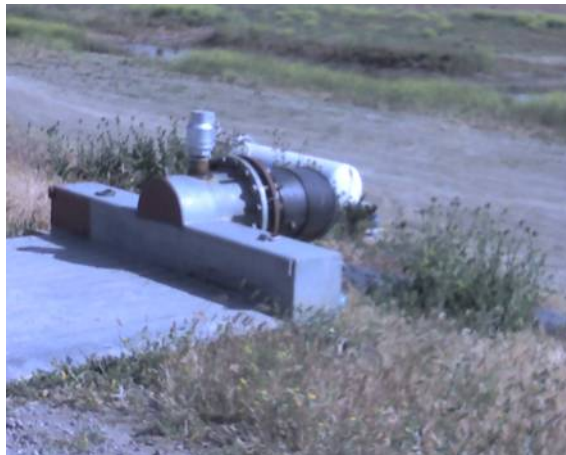
richard_s_20100601_088.jpg

Levee Mile Report Line	9
Start Levee Mile	32.96
End Levee Mile	32.96
Location	Land Side
Category	Earthen Levee
Item	Encroachments

Looking at waterside connection with siphon

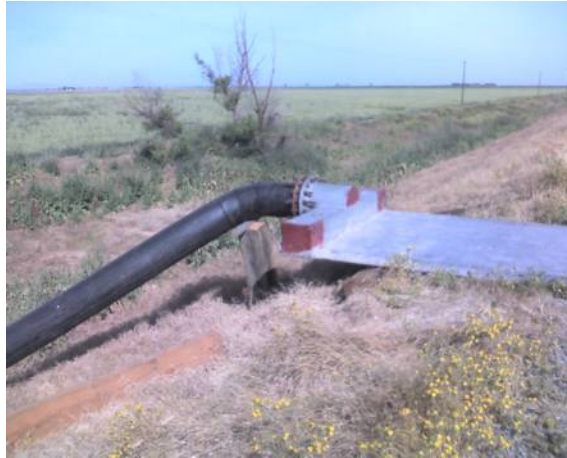
richard_s_20100601_089.jpg

Looking at landside connection.

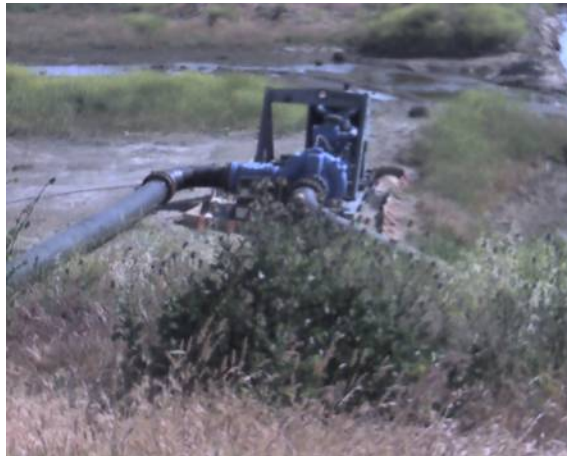
richard_s_20100601_090.jpg

Levee Mile Report Line	9
Start Levee Mile	32.96
End Levee Mile	32.96
Location	Land Side
Category	Earthen Levee
Item	Encroachments

Looking at pump on waterside berm (size of pump ???)

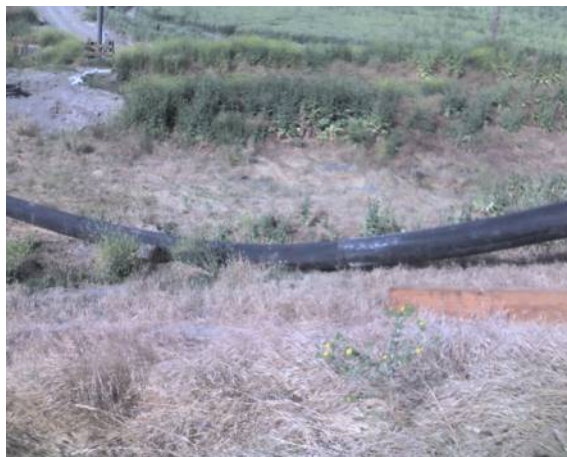
richard_s_20100601_091.jpg

Levee Mile Report Line	9
Start Levee Mile	32.96
End Levee Mile	32.96
Location	Land Side
Category	Earthen Levee
Item	Encroachments

Looking at 8-10 inch pipe on landside slope.

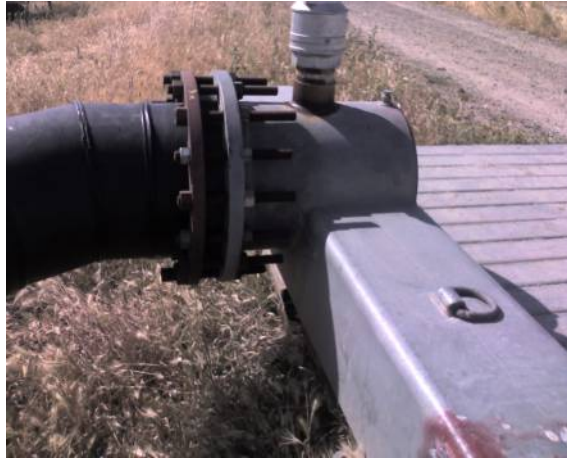
richard_s_20100601_092.jpg

Looking at close shot of waterside conncection with siphon.

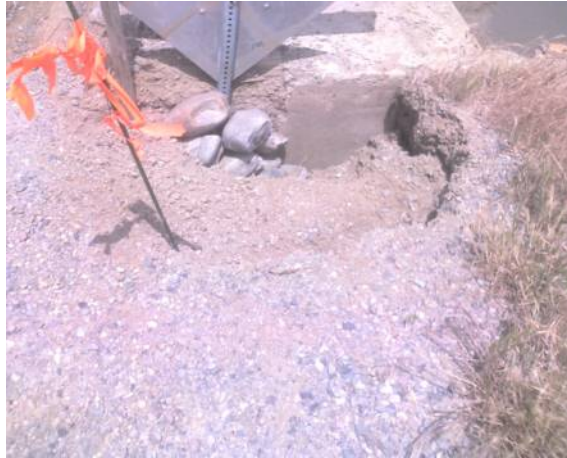
Levee Mile Report Line	3
Start Levee Mile	0.99
End Levee Mile	0.99
Location	Land Side
Category	Earthen Levee
Item	Crown Surface / Depressions / Rutting
Looking at hole on waterside shoulder next to control structure.	
richard_s_20100601_086.jpg
